# 環境整備と電気柵によるクマ対策

上田市（旧丸子）荻窪地区の取組

上小地区野生鳥獣対策チーム

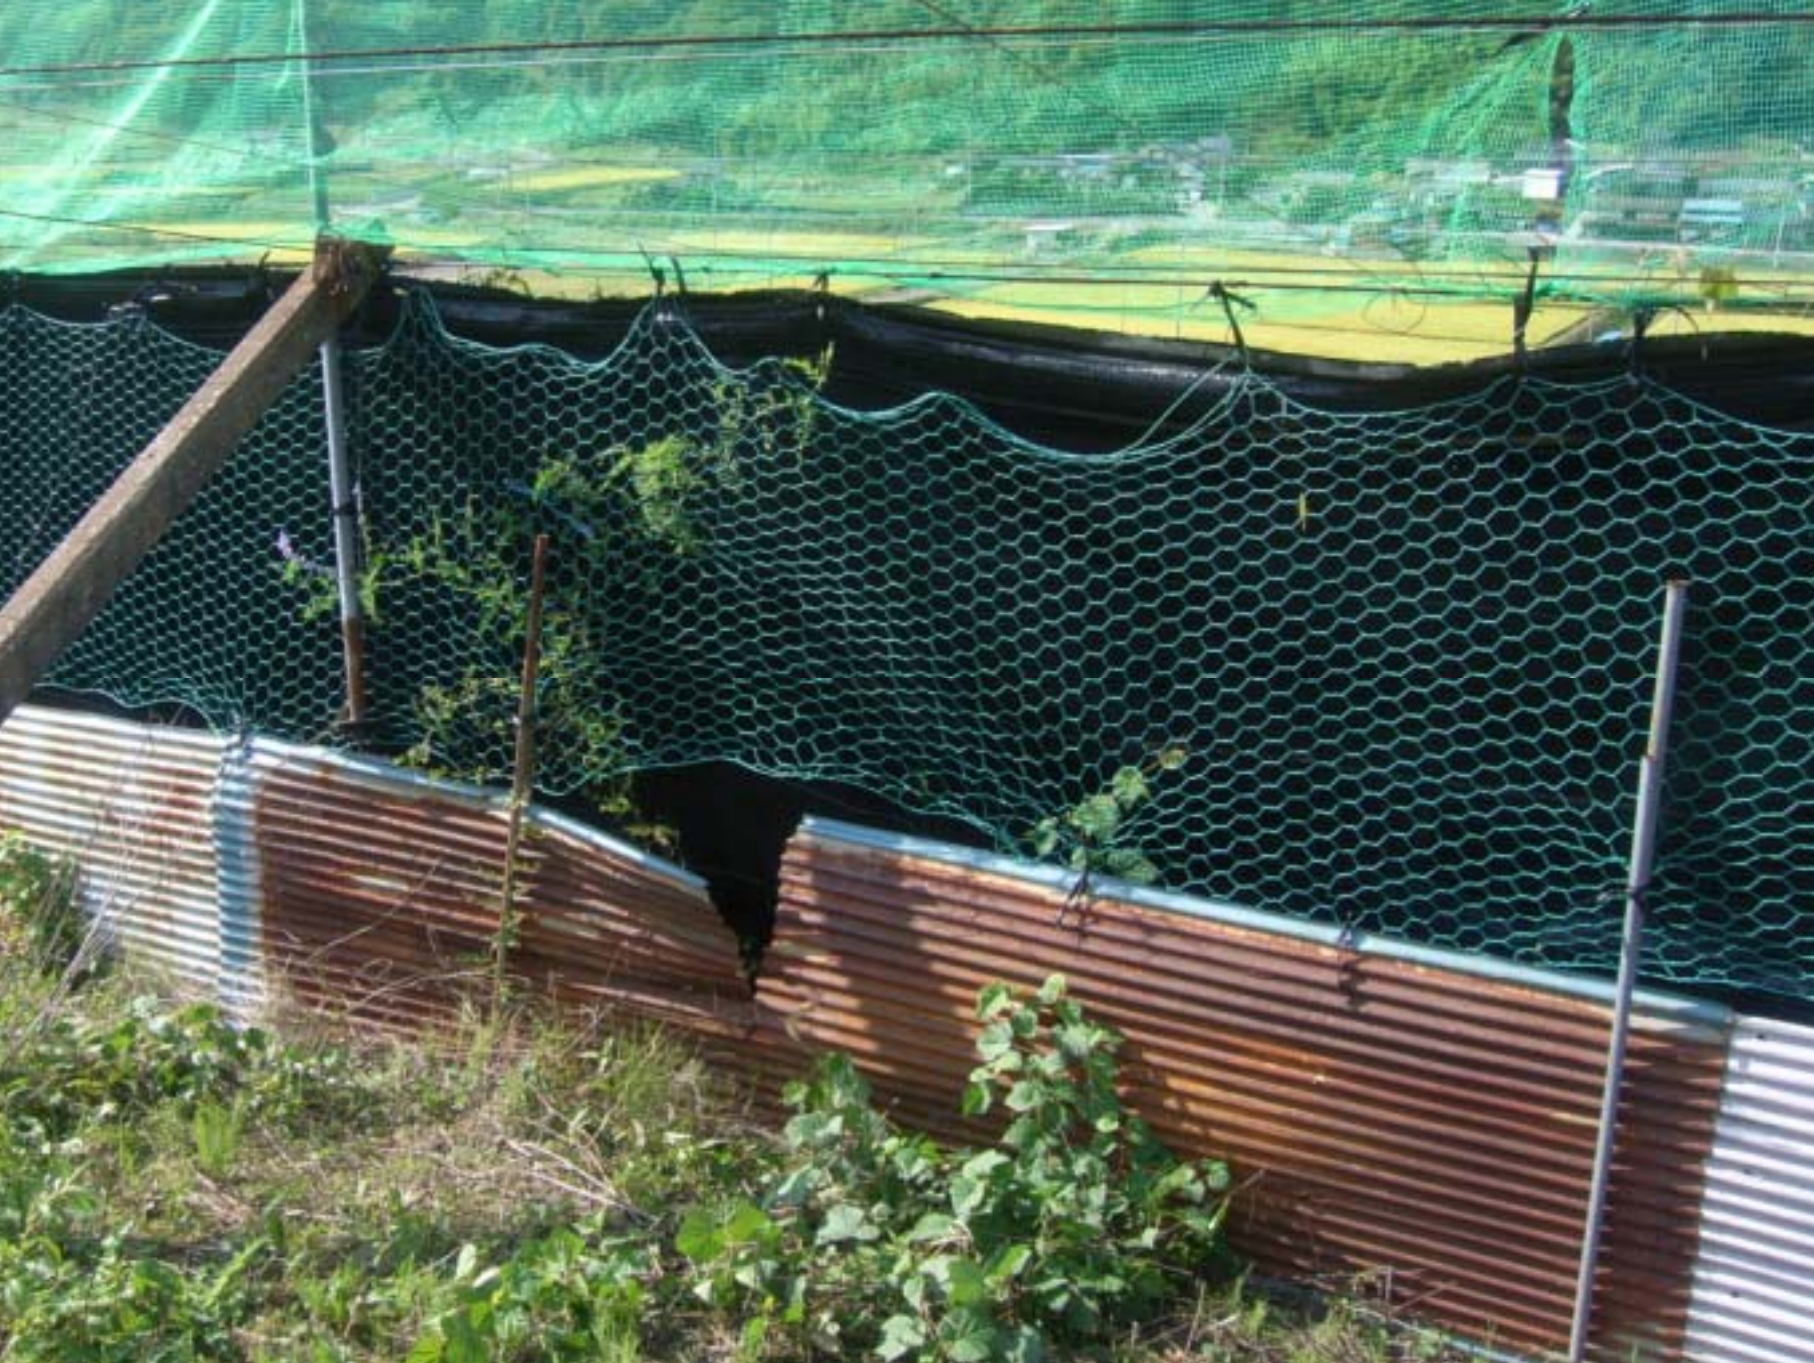
クマはトタン柵を  
破って侵入

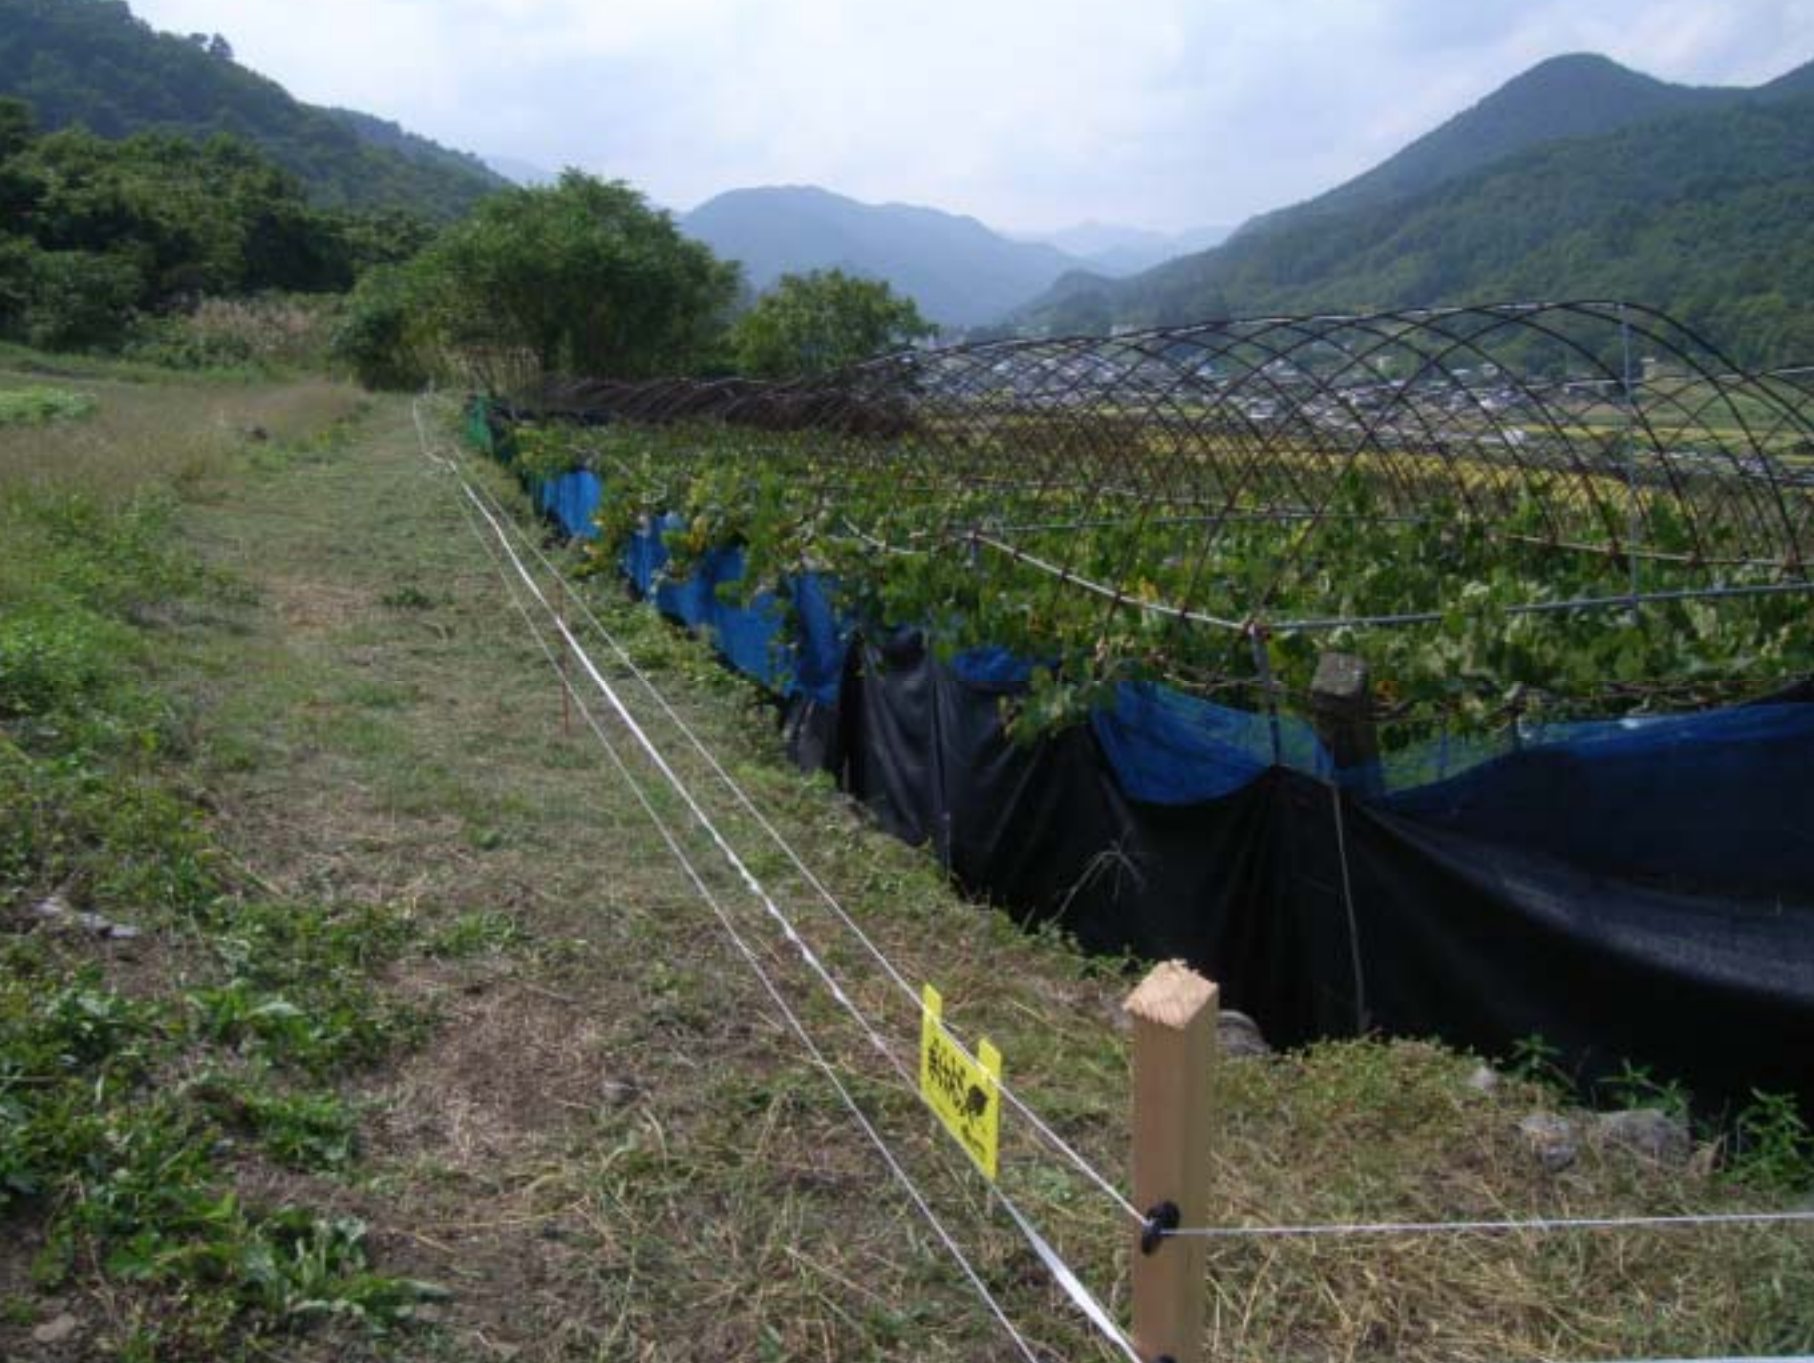
パワーユニット  
はGLLAGHERの  
B 1 1 が 1 台

柵の延長は230mの  
3段で690m  
明らかにパワー不足
